**DEPARTMENT OF TRANSPORTATION**

Contract #: 04-0120F4Cty: SF/ALA Rte: 80 PM: 13.2/13.9File #: 99.28**WELDING INSPECTION REPORT****Resident Engineer:**Siegenthaler, Peter**Address:** 333 Burma Road**City:** Oakland, CA 94607**Report No:** WIR-023845**Date Inspected:** 23-Jan-2011**Project Name:** SAS Superstructure**OSM Arrival Time:** 700**Prime Contractor:** American Bridge/Fluor Enterprises, a JV**OSM Departure Time:** 1900**Contractor:** Zhenhua Port Machinery Company, Ltd (ZPMC), Changxing Island **Location:** Shanghai**CWI Name:** Tian Lei, Liu Fa Wen**CWI Present:** Yes No**Inspected CWI report:** Yes No N/A**Rod Oven in Use:** Yes No N/A**Electrode to specification:** Yes No N/A**Weld Procedures Followed:** Yes No N/A**Qualified Welders:** Yes No N/A**Verified Joint Fit-up:** Yes No N/A**Approved Drawings:** Yes No N/A**Approved WPS:** Yes No N/A**Delayed / Cancelled:** Yes No N/A**Bridge No:** 34-0006**Component:** OBG**Summary of Items Observed:**

# WELDING INSPECTION REPORT

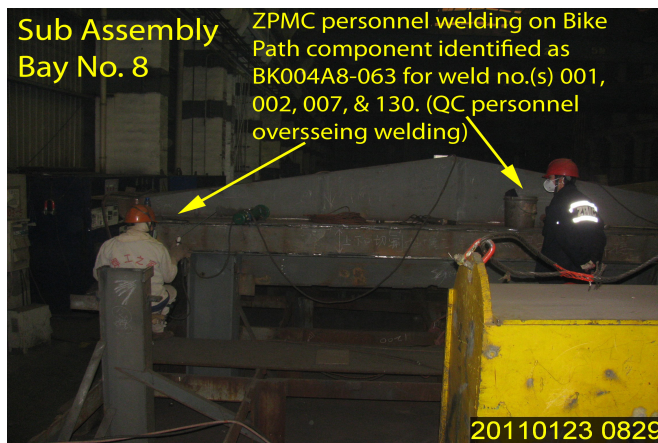
This QA inspector performed VT of approximately 100% of the area previously tested and accepted by ZPMC Quality Control personnel. All components were as listed on NWIT notification no. 08269. The member(s) is/are identified as OBG Bike Path identified as components BK4A-063.

Unless otherwise noted above all items observed on this day appeared to be in general compliance with the applicable contract documents
